# Manhole Inspection Summary

Manhole # S57K\_\_006MH

Insp Date: **5/15/08 12:07 PM**

**Location** Address: **foster ave**

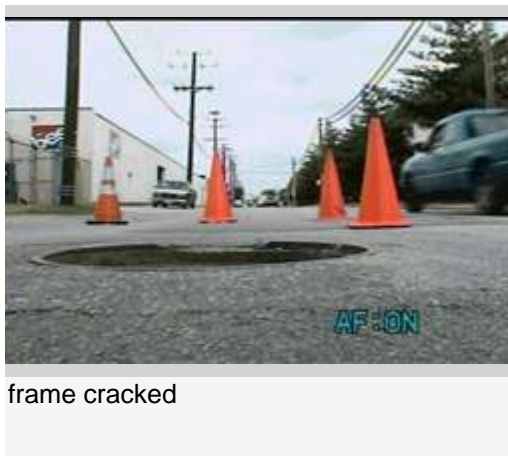
Defect

☒ **Cracked**

☒ **Leaks**

frame cracked

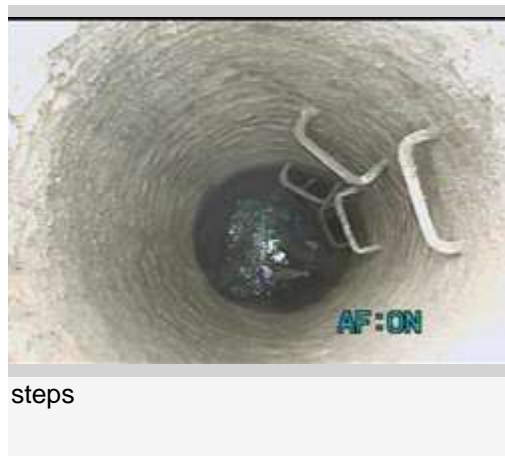
Defect 2

Count: **14** Missing: **0** ☒ **Corroded**

steps

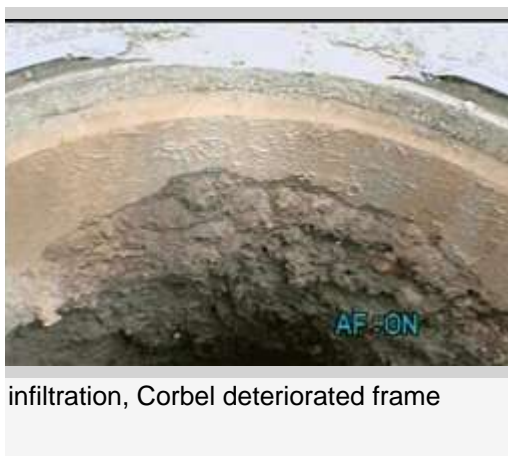
Defect 1

Condition: ☐ Sound ☒ **Cracked** ☐ Root Intrusion ☐ Loose Brick ☐ Deteriorated

Infiltration: ☐ None ☒ **Joint** ☐ Cracks ☐ Mortar ☐ Roots ☐ Wall

infiltration, Corbel deteriorated frame

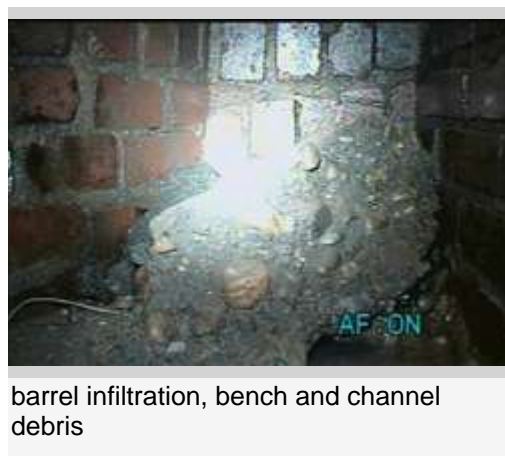
Defect 3

Infiltration: ☐ None ☐ Joint ☐ Cracks ☐ Mortar ☐ Roots ☒ **Wall**

Condition: ☐ Sound ☐ Cracked ☐ Root Intrusion ☐ Deteriorated ☐ Leaks ☒ **Debris**

barrel infiltration, bench and channel debris

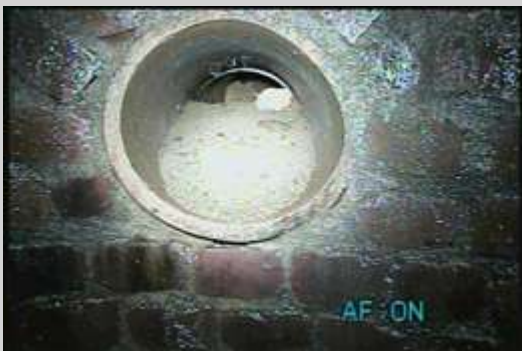
3 O'Clock Inflow

Deposits: ☐ None ☐ Mud ☐ Sludge ☒ **Debris** ☐ Grease

Silt Depth: 3 (in.) Deposits Extent: **Medium**

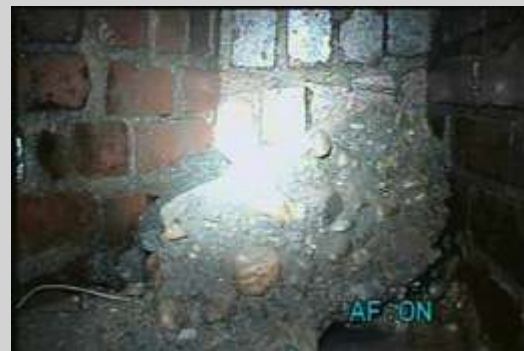
Drop In @ 3 O'Clock

Drop Condition: **Clogged**
